Docket No. 217 – Development and Management Plan Inspection

Northeast Utilities Service Company Certificate of Environmental Compatibility and Public Need for the construction of a 345-kV electric transmission line and reconstruction of an existing 115-kV electric transmission line between Connecticut Light and Power Company's Plumtree Substation in Bethel, through the towns of Redding, Weston, and Wilton, and to the Norwalk Substation in Norwalk, Connecticut.

Date: January 26, 2006

Location: Overhead Line (Composite 345kV and 115kV Gallows Hill to Archers Lane) and (345kV H-Frame Hoyts Hill to Gallows Hill)

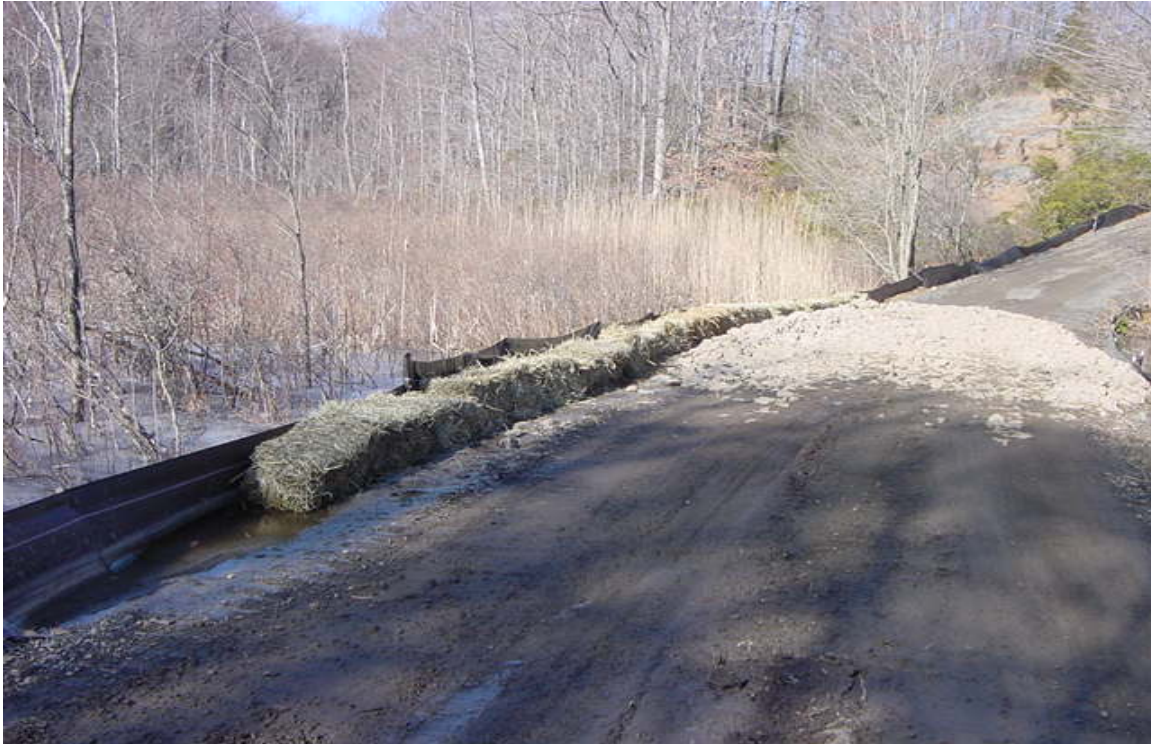
(Composite Section): Photo shows a view of the 2nd crossing past Archers Lane. Water levels have receded slightly but new stone was also placed in the crossing. Haybales were installed along the silt fence and controls were improved. 1/26/06

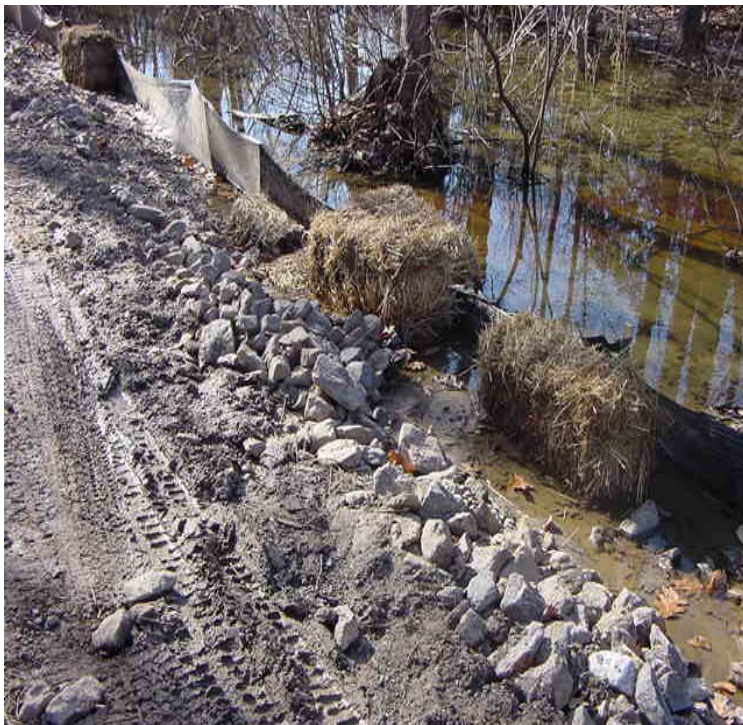
Photo on the left shows the first wetland crossing along the ROW access road where sediment from run-off has settled within the wetland. Solutions to improving the erosion controls here are needed. Photo on the right shows the view to the station from the ROW. 1/26/06

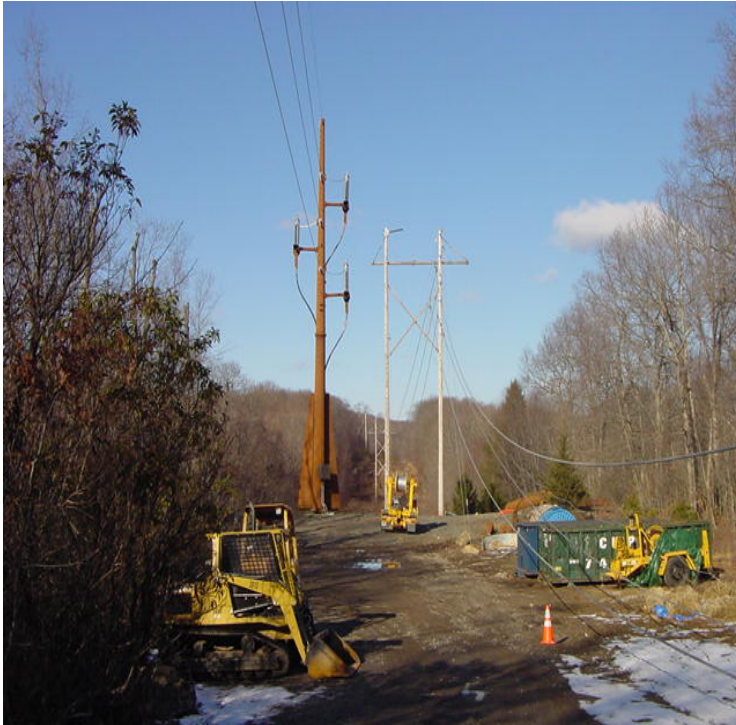
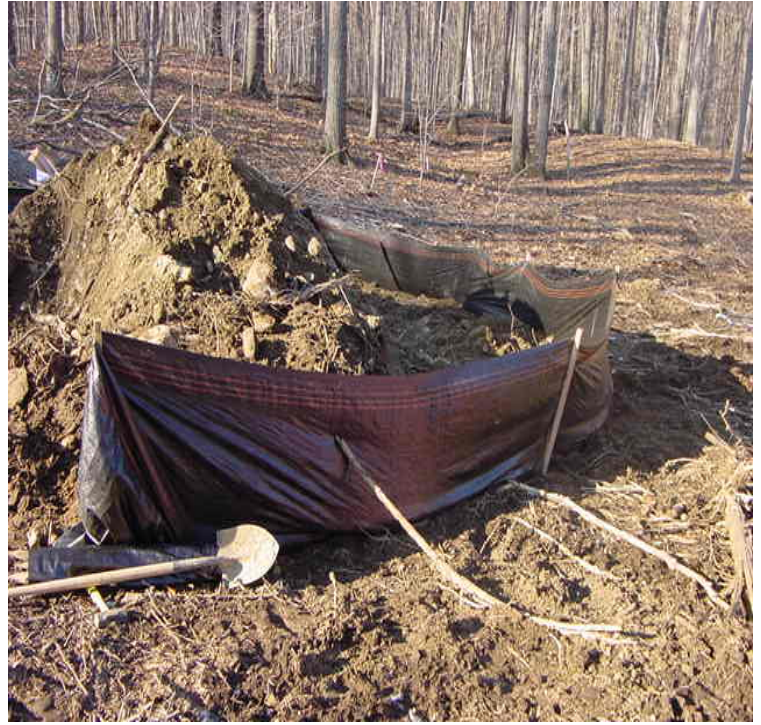
Photo on the left shows the 1st structure in from Gallows Hill with cable being released from the old pole. (345kV H-frame) Photo on the left shows a stockpile with controls installed on the Bethel Reservoir stretch. 1/26/06

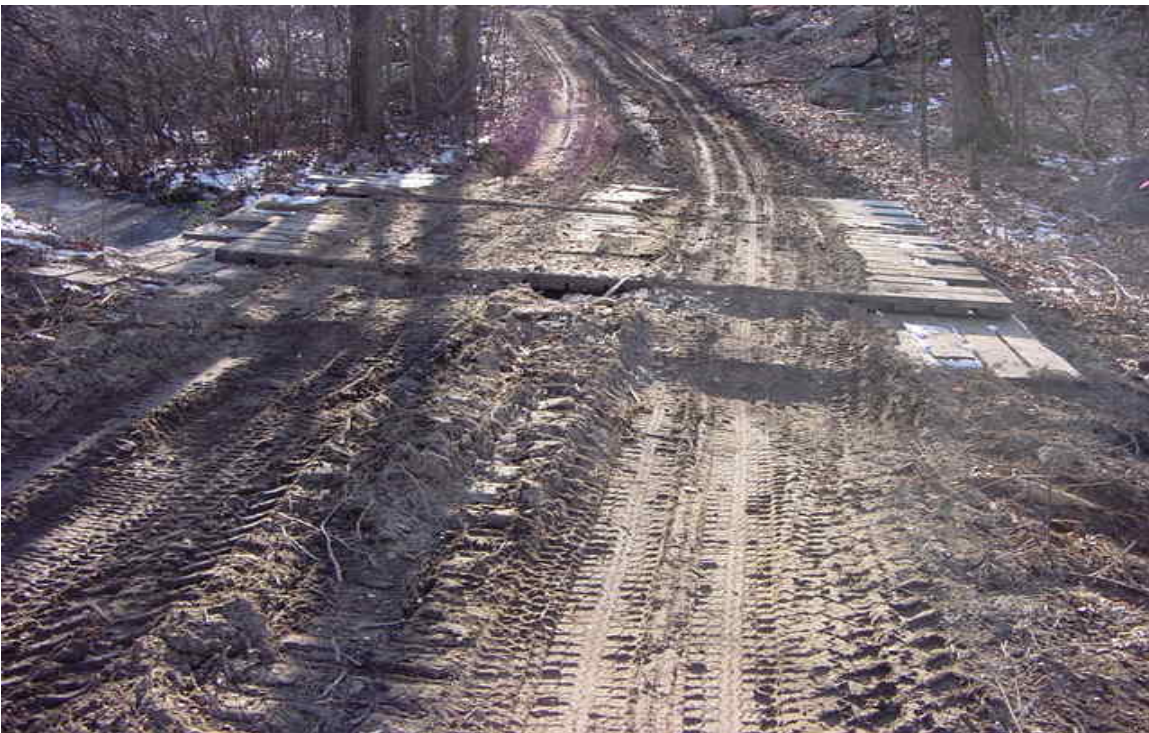
345kV (H-Frame Section): Photo shows a wetland crossing within the ROW in the Bethel Reservoir section. With the soil disturbance, erosion controls have to be placed on the approach to the mat along all "four corners" to keep sedimentation to the wetlands. 1/26/06

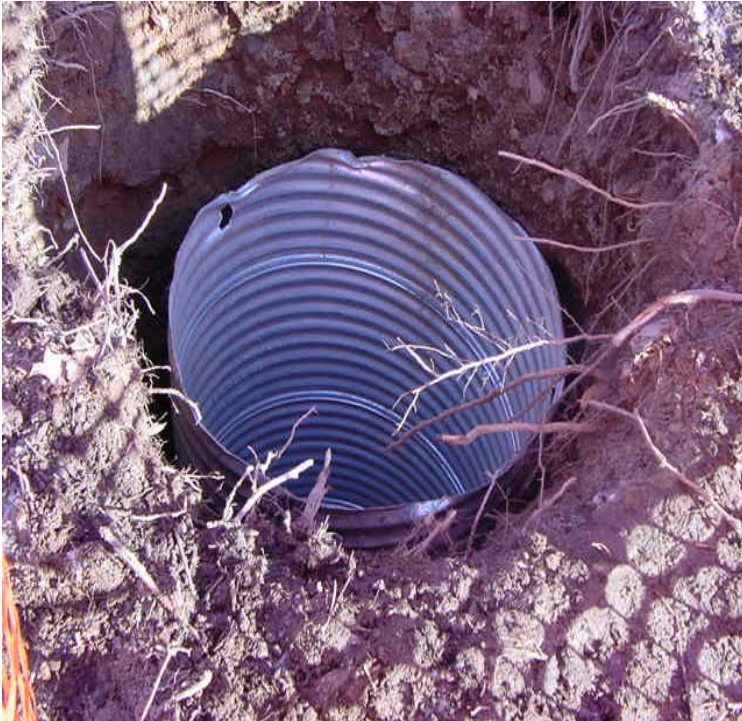
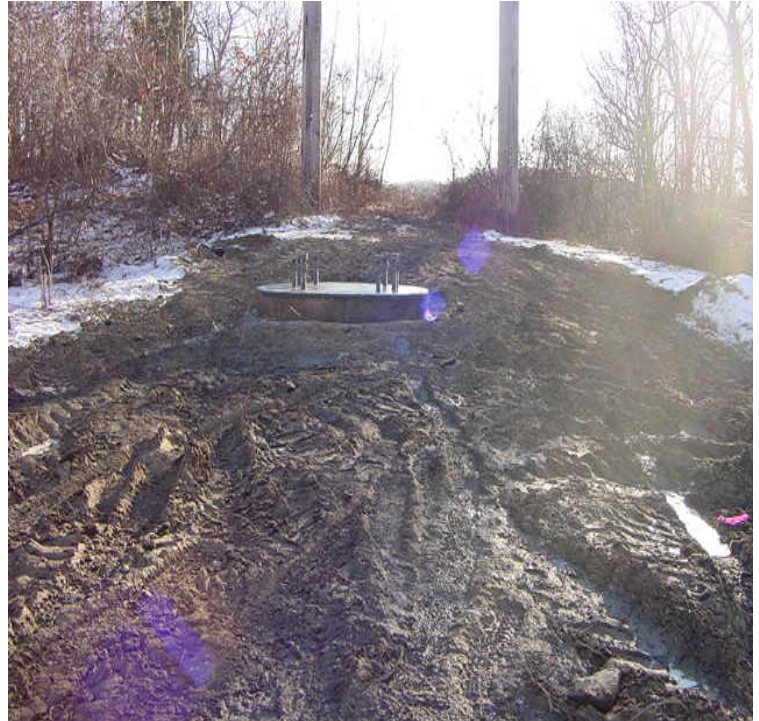
Photo on the left shows the excavation for a wooden pole installation. Photo on the right shows a foundation in place off Nashville Rd. 1/26/06

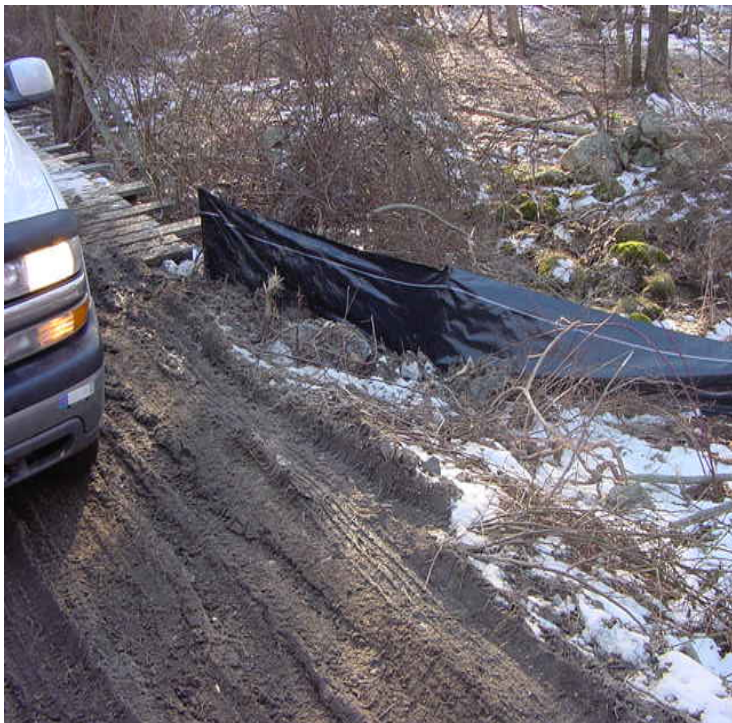
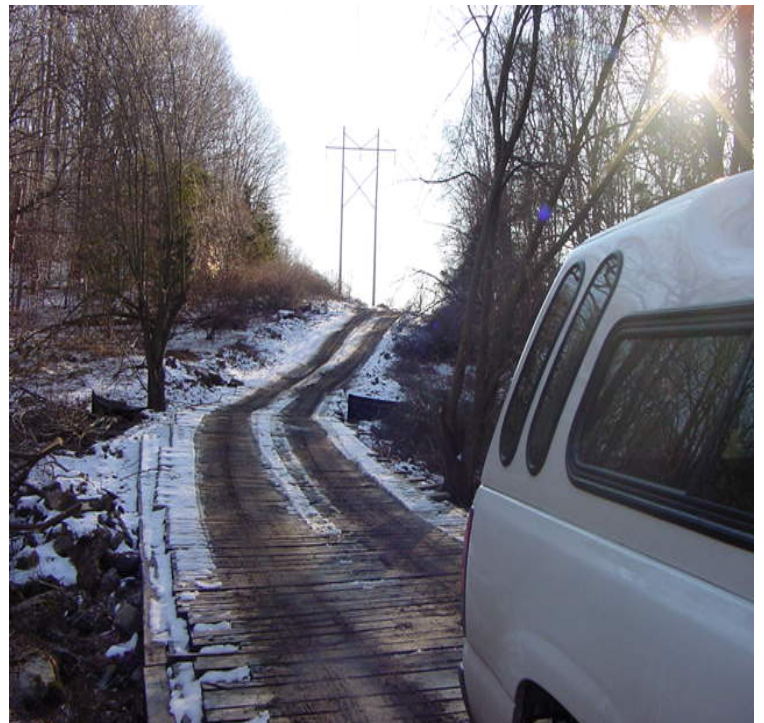
Both photos show a view of the wetland crossing between structures 6 and 7 on the Chestnut Ridge to Hoyts Hill section. Erosion controls have been installed at the 4th corner as recommended. Make sure all controls remain maintained and extended to the mat. 1/26/06

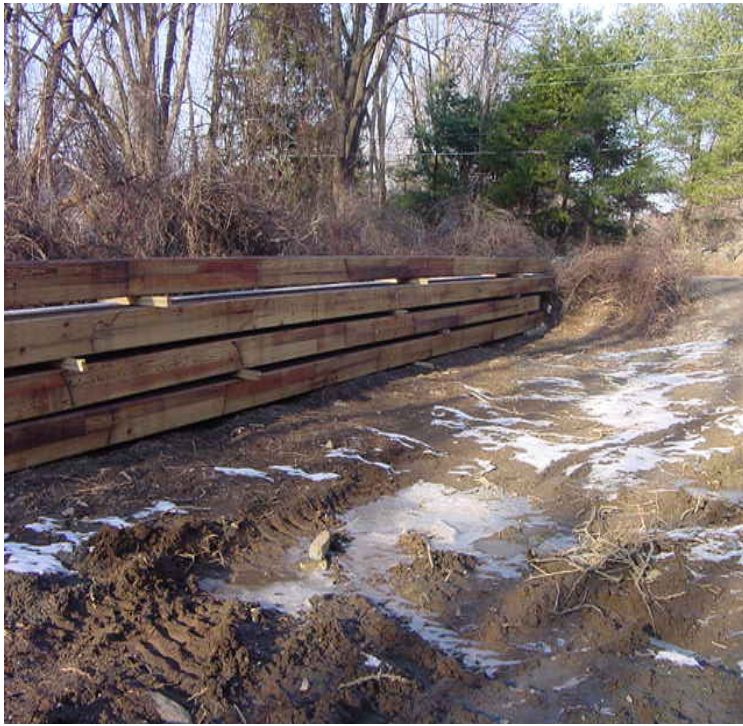
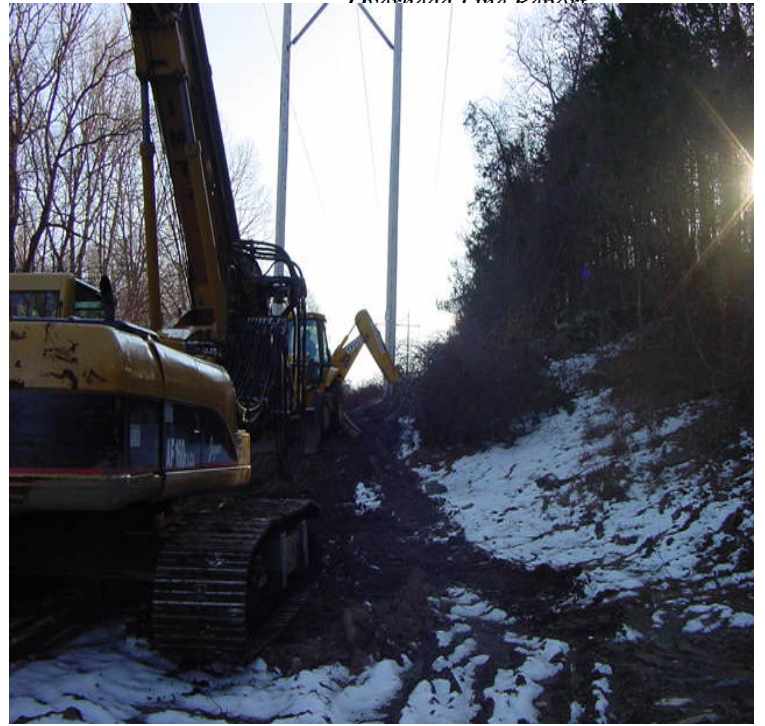
Photo on the left is a view of some of the wooden poles being stored along the ROW. Photo on the right shows active drilling for structure foundations in this section. 1/26/06

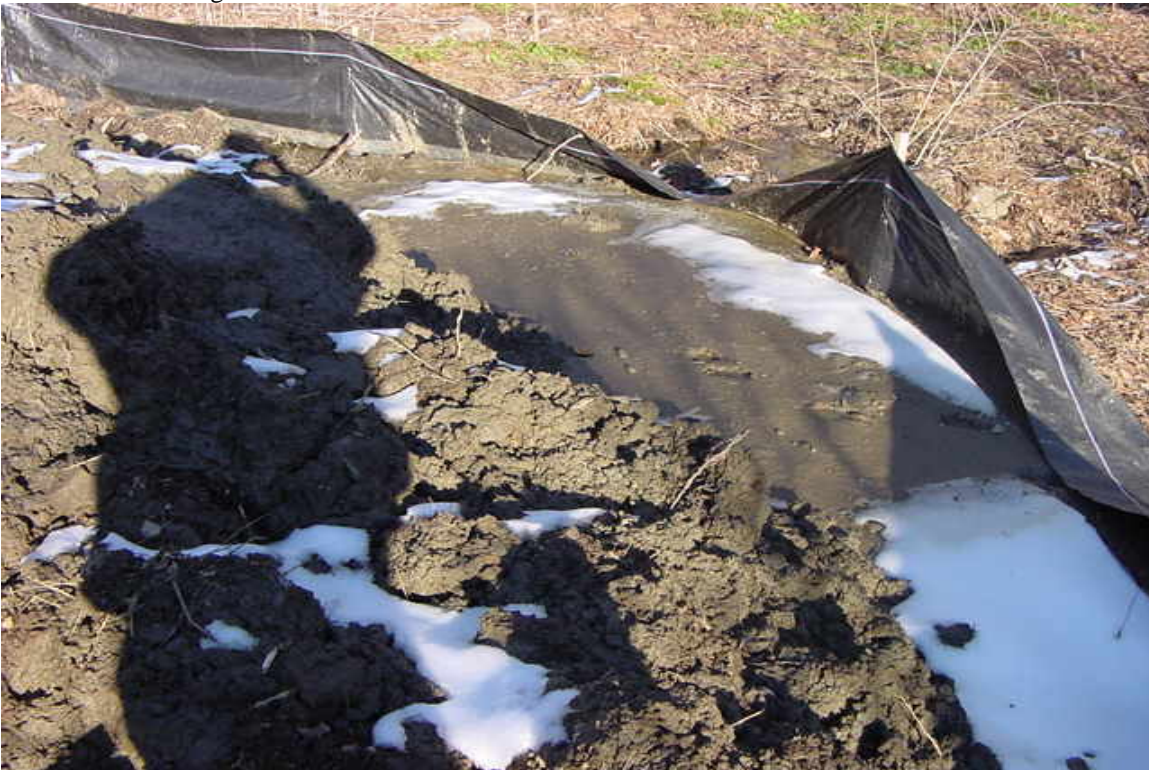
Dewatering	<p>- Dewatering was needed at the excavation for structure #6 last week. Amounts of water and sediment overwhelmed the few haybales and silt fence that had been placed and tracked down slope to a wetland at the base. 1/19-1/26/06</p> <p>- Active dewatering was not noted at this structure this week. 1/26/06</p>	- Release water to the ground only in well vegetated areas if it will not reach any resource areas. Otherwise use a filter bag or containment of some kind. 1/26/06
Blasting	-No blasting has been necessary at this time on the ROW. 1/26/06.	-None at this time. 1/26/06.
Spills and Material Storage	- No drips or leaks were noted under any of the vehicles this	- Continue to keep all vehicles maintained well (i.e. no apparent fluid leaks) if they

Photo shows the extensive soil resulting from the excavation at proposed structure #6. The soil still needs to be pulled back and removed from the wetlands. 1/26/06
